27 GRC – STANDING THE TEST OF TIME

G.T. GILBERT

Cem-FIL International, Skelmersdale, Lancashire WN8 9PS, UK

SUMMARY: This paper demonstrates how GRC has been used for more than 30 years to create a variety of unique architectural buildings that have stood the test of time in a wide range of climatic conditions throughout the world.

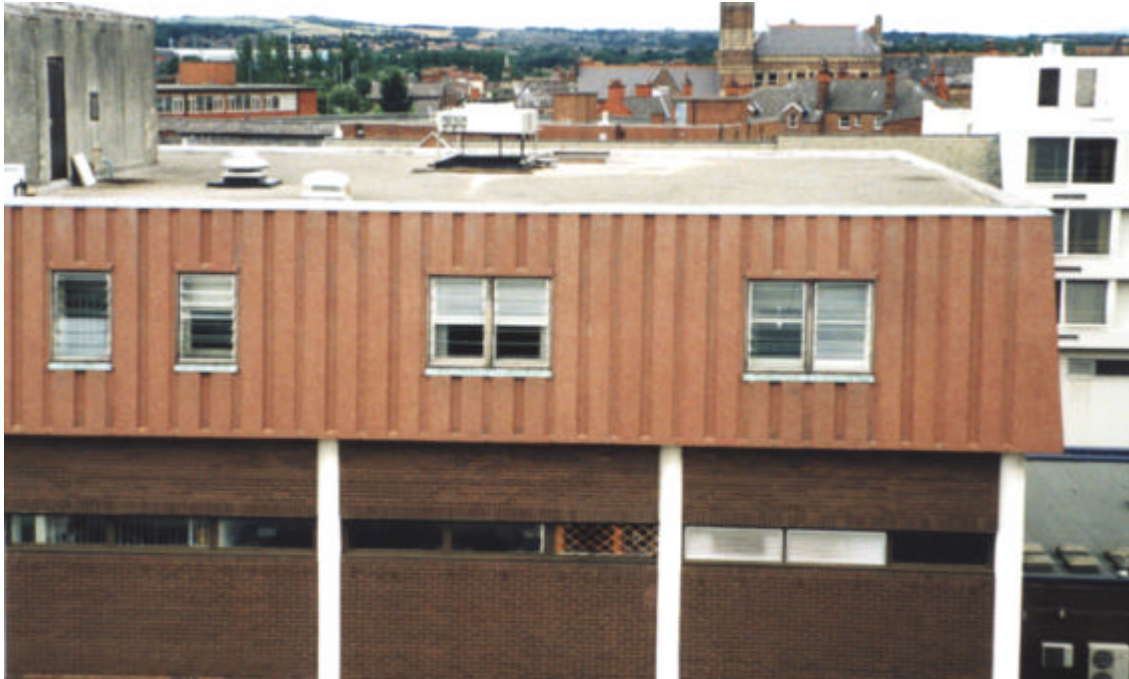
Figure 1: 1974 Boots building, St Helens seen in July 2003.

One of the earliest contracts in GRC was a small extension to the Boots Building at St Helens, Lancashire in northern England. In total, 70 single-skin ribbed panels coated in Mineralite were installed to form the top storey of the building. The architects were Seymour Harris.

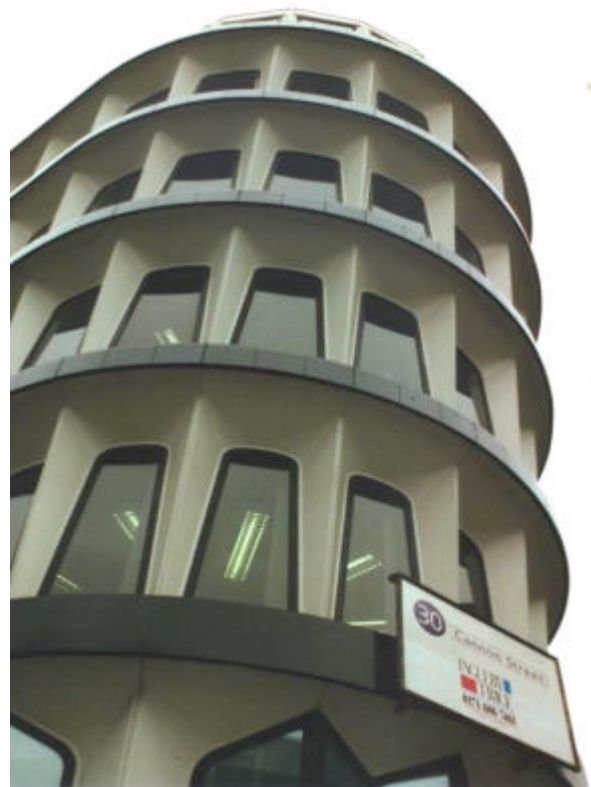
Figure 3: The light weight of GRC panels allowed this building in the City of London to incline outwards by 5 degrees thus increasing usable floor space. Nearly 30 years on, it is still a landmark building in excellent condition.

1974 was a good year for GRC in the UK since it was also used to spectacular effect by the architects Whinney Son & Austin Hall, when they created the seven-storey Credit Lyonnais bank premises in the City of London: 1900 double-skin GRC panels were made using a plain white cement finish. The building inclines outward by 5 degrees, possible because of the light weight of the GRC panels, thus gaining extremely valuable floor space in the centre of the expensive City of London. As can be seen from this recent picture, Figure 3, it is still a landmark building.

In 2003, this building was examined by the internationally renowned consultants Arup, and the positive report of Arup Materials Consulting is presented in detail in another paper at this congress.

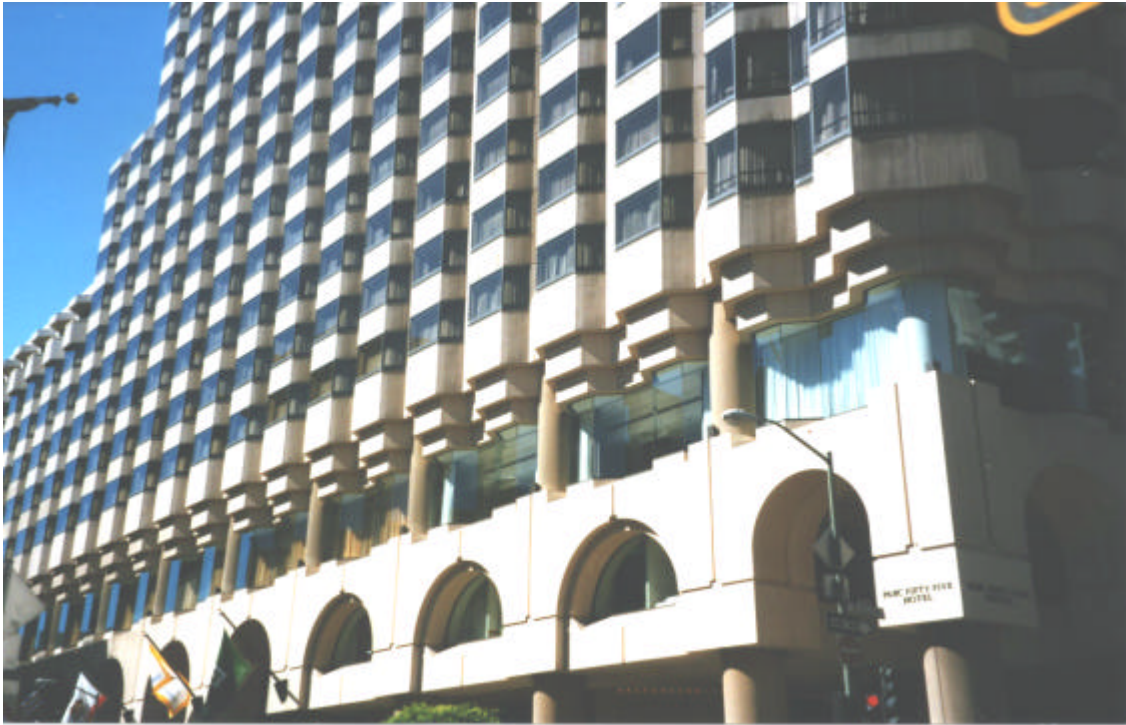
Figure 4: Parc Fifty Five, San Francisco. A variety of sculptured panels were created in GRC – from fluted, circular and oval column covers to delicately combed, three-dimensional spandrel panels and large arches with deep rustic joints: 3624 GRC panels cover 17,000 m² in total.

In the USA, 20 years ago, the light weight of GRC panels combined with their ability to be moulded into complex but durable shapes was used to good effect by the architects Daniel, Mann, Johnson & Mendenhall on the 32-storey Parc Fifty Five building in San Francisco. Originally constructed in 1984 as the Ramada Renaissance Hotel, it has survived the aggressive San Francisco urban environment for 20 years without a single refurbishment of the exterior and it still looks as pristine as the day that it was erected, as can be seen from the recent photograph in Figure 4.

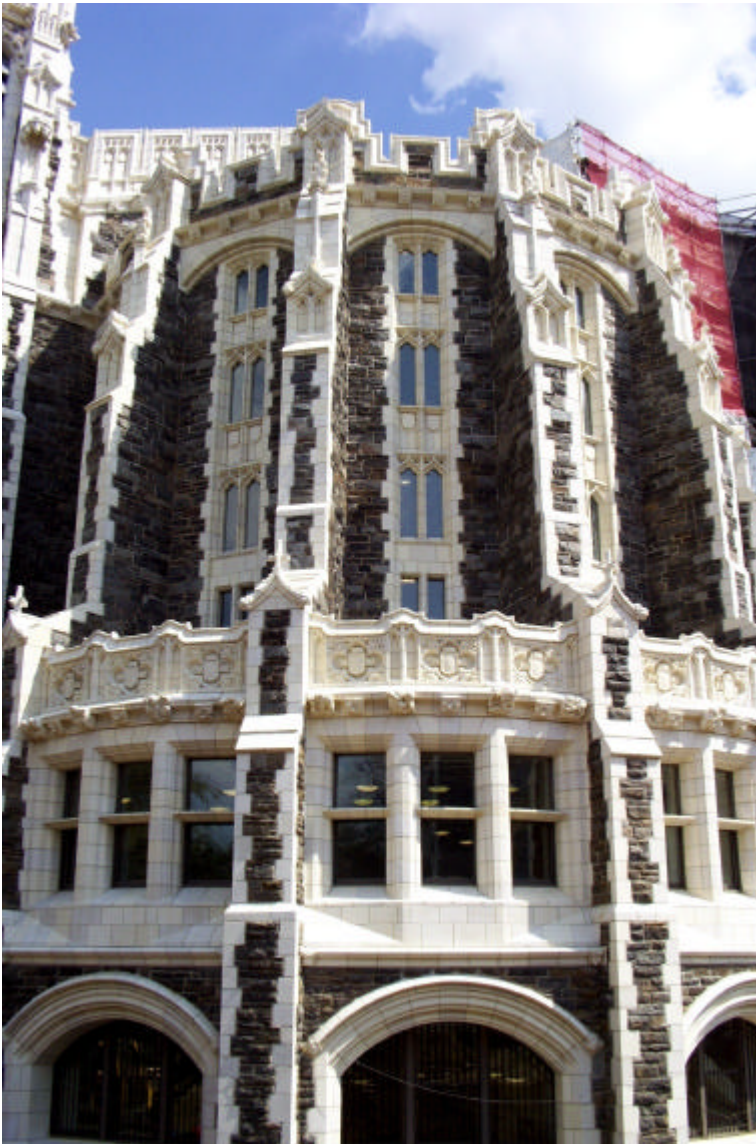
Figure 5: The reconstruction of the exterior of Shepard Hall, built in 1907, is a multi-phase project that will eventually lead to the replacement of 72,000 units and over 4000 shapes, including many ornate sculptures. The project is still on-going and it is a tribute to GRC that many of the new elements are being fixed next to 10-year-old pieces with no discernable differences being visible.

Also in the United States, there is another fine example of how GRC was extensively laboratory tested and then used to good effect more than 10 years ago for the refurbishing of a building in the aggressive urban environment of New York City. In 1991, GRC was approved by the architect, Carl Stein, for use on the prestigious refurbishment of Shepard Hall after completing the following battery of standard ASTM tests methods:

G-23	Accelerated weathering for 2000 hours
D-2249	Humidity resistance for 1000 hours
B-117, modified	Acid-rain resistance for 2000 hours
C-67	Freeze–thaw resistance for 50 cycles
C-666, modified	Rapid freeze–thaw for 100 cycles
C-67	Water absorption
C-67	Efflorescence
D-3273	Mildew resistance.

This testing programme required 4–5 months to complete. These tests were aimed at predicting the long-term effects of the New York environment on the appearance and stability of the panels over a predicted life of more than 50 years

Phase 1 was completed in 1992, and required 12,000 replacement units. The project replaced the upper 20 m of the main tower, clerestory window surrounds, copings and finials. In Phase 2, a further 6200 units were used to replace tracery and window surrounds for 12 stained glass windows 11 m high, ten highly decorated finials 7 m high, and various copings, mouldings and quoins. Phase 3 (see Figure 5) required about 11,500 replacement units, involving the reconstruction of a 35 m-tall tower, six projecting bay windows, each 11 m high \times 6.7 m, numerous moulding surrounds, copings and quoins.

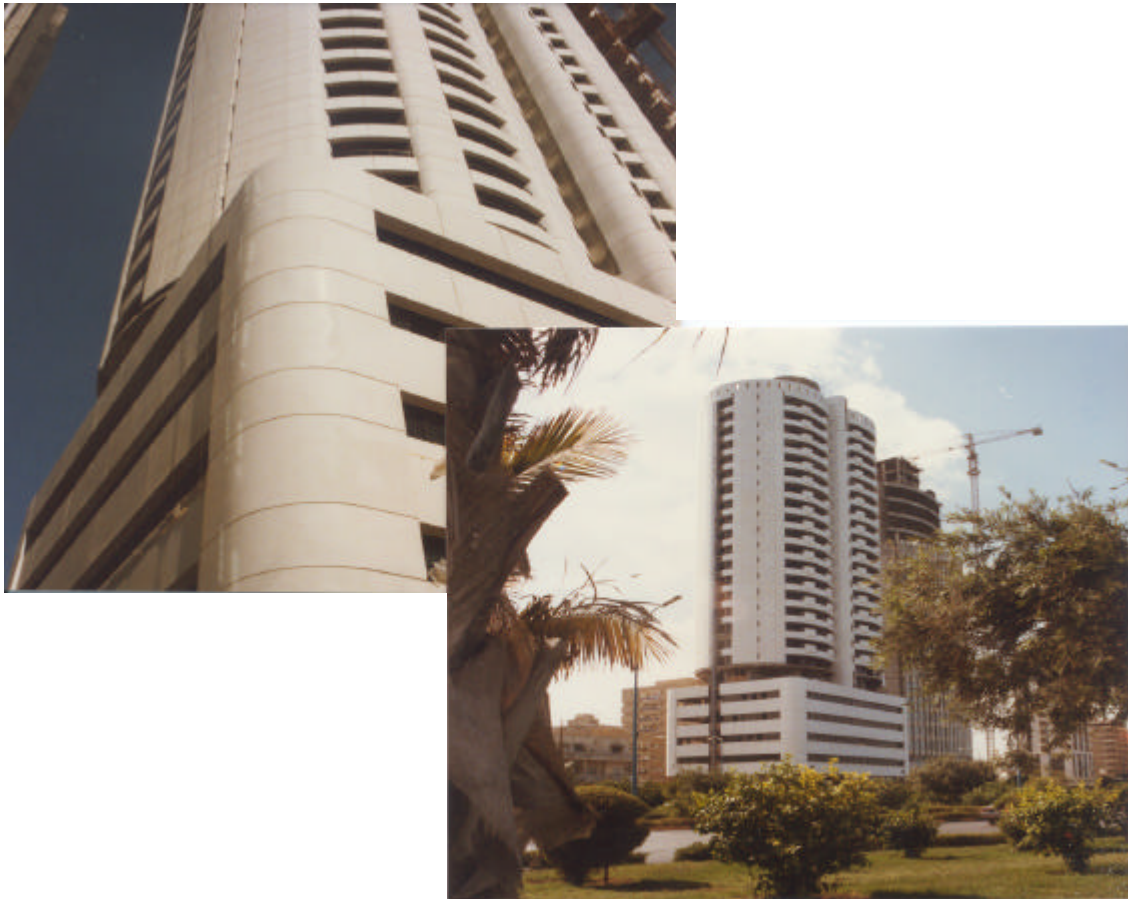
Figure 6: Corniche Towers, Abu Dhabi: nearly 10,000 m² of GRC has given 20 years of trouble-free performance in the Middle East's hot, salty and sandy environment.

Middle Eastern countries have, for more than 20 years, also created a large number of architecturally individual buildings using GRC panels and decorative details. Figure 6 is a fine example of this. Completed in the early 1984, the Corniche Towers was, at the time, the tallest building in Abu Dhabi. The GRC was specified from the outset and considerable savings were achieved in the main structure and foundations because of the light weight of the GRC panels. In total, 1532 panels with 26 variations were rapidly hoisted into place with a tower crane and later manhandled to their final position. 9736 m² of GRC that has given 20 years of trouble-free performance.

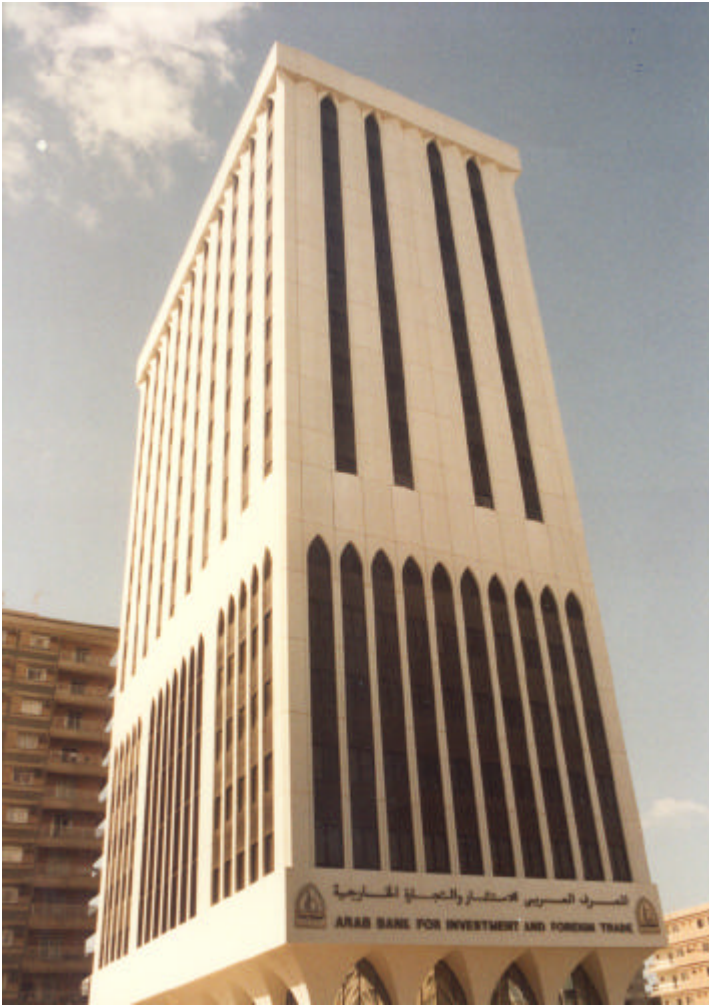
Figure 7: Arab Bank for Investment and Foreign Trade. The architects demanded “narrow soaring arches”, which have stood the test of time over the past 22 years.

Even earlier, in 1981, the Arab Bank for Investment was built, with the architects, ACG, demanding “ narrow, soaring arches in smooth white GRC” (Figure 7). A total of 4970 m² using 864 panels were used. Because of the fine airborne sand in the region, the building has been re-painted but other than that, the GRC has performed extremely well.
